Date: 2023

Revision No. 1.0

Technical evaluation

Irradiation of the Versatile Link + Demo Board (VLDB+) with neutrons

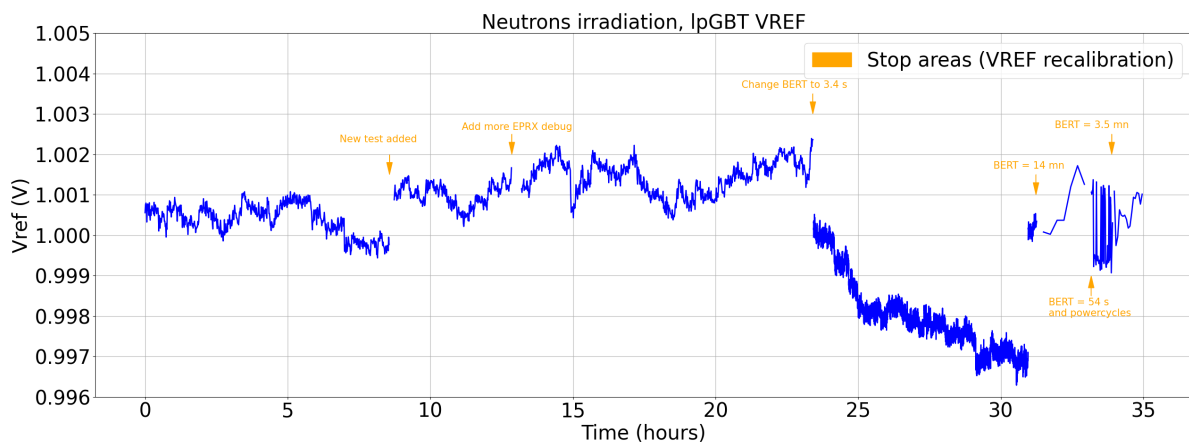
Figure 9: VREF during irradiation

Just before the irradiation, the IpGBT's VREF was calibrated to be as close as possible to 1 V. During the 35 hours of irradiation, there were 6 specific moments where the VREF control register was re-calibrated, explaining the jumps of the voltage reference value. The re-calibration software tries to find the best code for a VREF value with an error of 1 mV at maximum. In some cases, as in the first re-calibration, the VREF value worsens after re-calibration since it stops searching for the best code as soon as it gets a value with an error of less than 1 mV. Between the periods of time where the system was not restarted, the VREF remained stable around 1 V. The only period of time where a significant voltage decrease of 3 mV occurred was between 23h 21mn and 31h 10mn.

It is important to mention that the VREF generated by the IpGBT is used internally by the chip for its ADC and DAC IPs. Therefore, any variation of the VREF is expected to impact their performance.

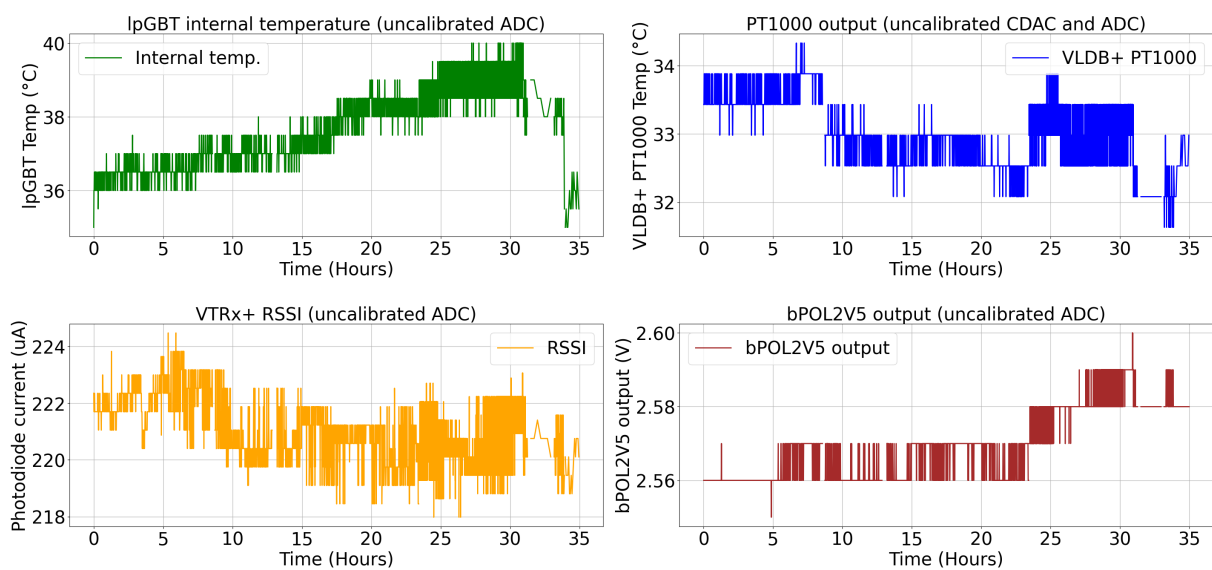
Figure 10: Performed IpGBT ADC readings during irradiation

In Figure 10, the reading of the four ADCs during irradiation is shown. Since the internal temperature monitor, ADC and CDAC of the IpGBT under test was not calibrated before irradiation, the temperature, current and voltage values that are shown have a non-negligible error. Since this error can be reduced by using calibration values, the main goal of this test was to ensure the operation of the ADC and CDAC features rather than the precision of the obtained values.

It can be seen that during the 35 hours of irradiation, the ADC values could be read without interruption. The ADC and CDAC features did not suffer from SEU and no drastic value changes that could not be explained by VREF re-calibration drifts or sudden temperature changes (due to power cycles) could be seen.

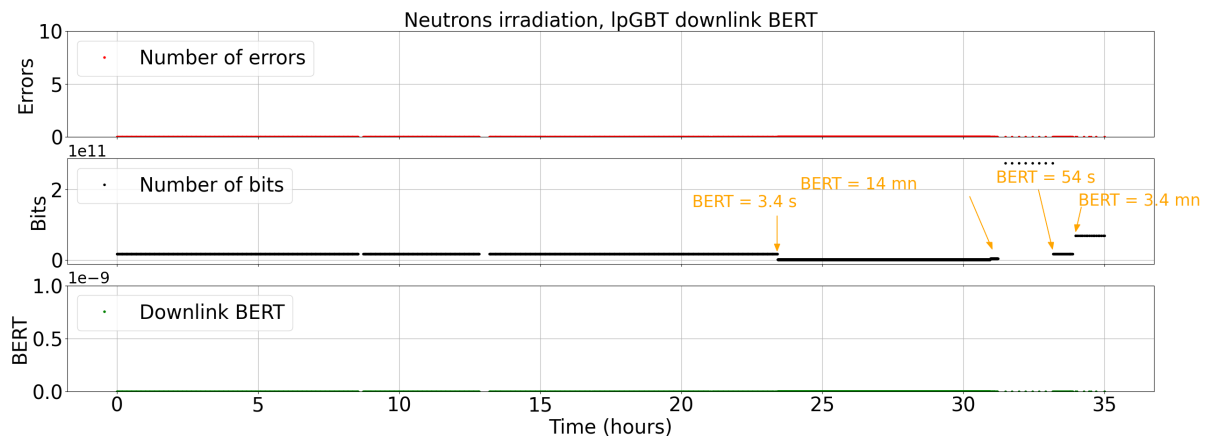
Figure 11: IpGBT Downlink BERT during irradiation

During irradiation, the BERT duration changed in different moments of the test to have more statistics. In Figure 11, 3 different plots are shown: number of errors, number of bits and BER (errors/bits). As it can be seen, not a single downlink error was detected during all the irradiation (except for some burst errors explained in Section 7)

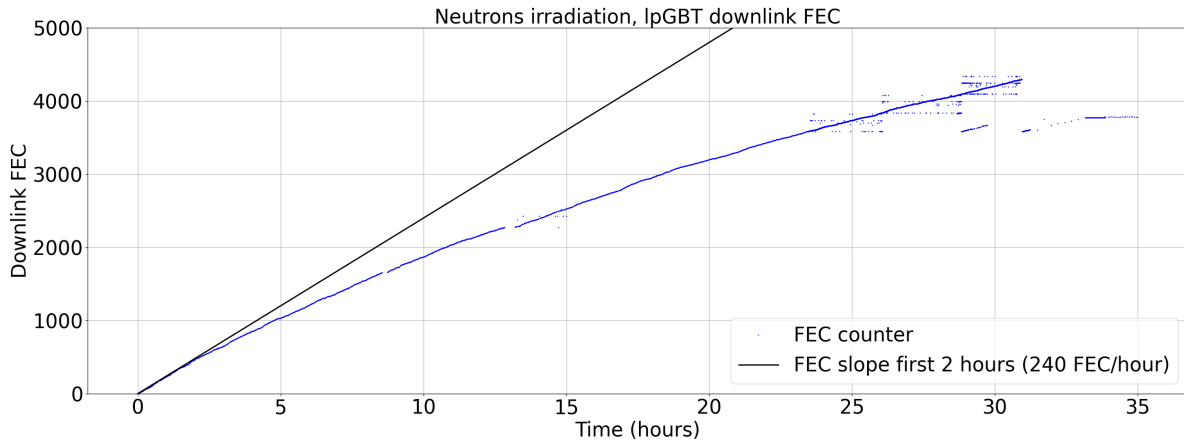
Figure 12: IpGBT Downlink FEC during irradiation

During irradiation, the downlink Forward Error Correction (FEC) was constantly increasing and protecting the downlink receiver against errors. In Figure 12 the downlink FEC during irradiation can be seen. A black line shows the FEC slope during the first 2 hours of irradiation. This visual help shows that the FEC slope decreased during irradiation: the FEC slope was decreasing at a rate of around 100 FEC/hour.

The most plausible explanation for this behavior is that the photodiode acts as a particle detector. As it degrades over time when being irradiated, it becomes less sensitive to neutrons. Nevertheless, since the optical data has a low attenuation the photodiode still detects it and does not lose performance.

In the plot it can be also seen that the FEC counter between hour 23 and 33 was showing values that were not following the curve. This was due to software problems that are explained in Section 7.

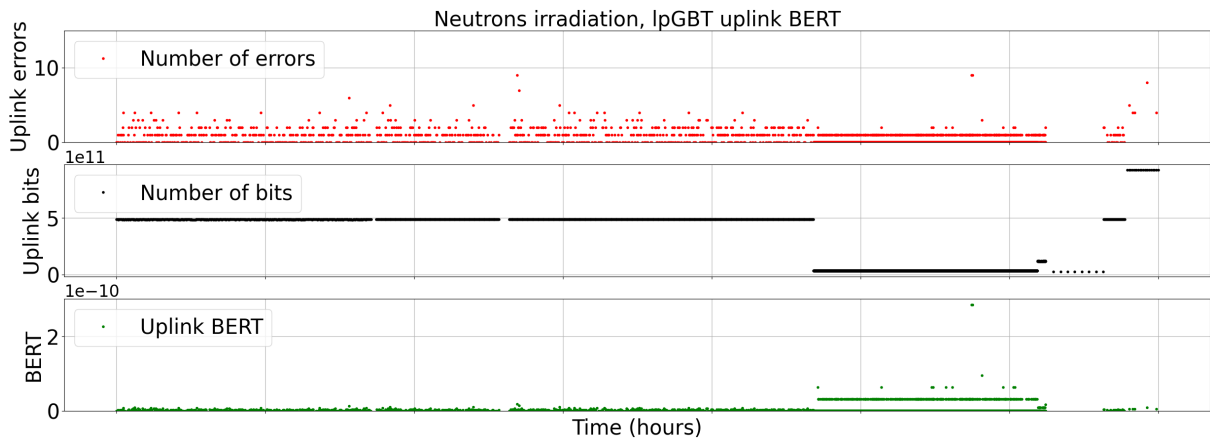
Figure 13: IpGBT Uplink BERT during irradiation

During irradiation, the BERT duration changed in different moments of the test to have more statistics. In Figure 13, 3 different plots are shown: number of errors, number of bits and BER (errors/bits). Since the uplink data PRBS pattern generator was not designed to be protected against SEU, some sporadic uplink errors were detected during the irradiation. Moreover, between hours 31 and 33 where the BERT duration changed from 3.4 seconds to 14 minutes, it can be seen that the number of uplink bits do not correspond to a longer BERT time. This was due to an unexpected overflow on the firmware that caused to have no uplink errors.

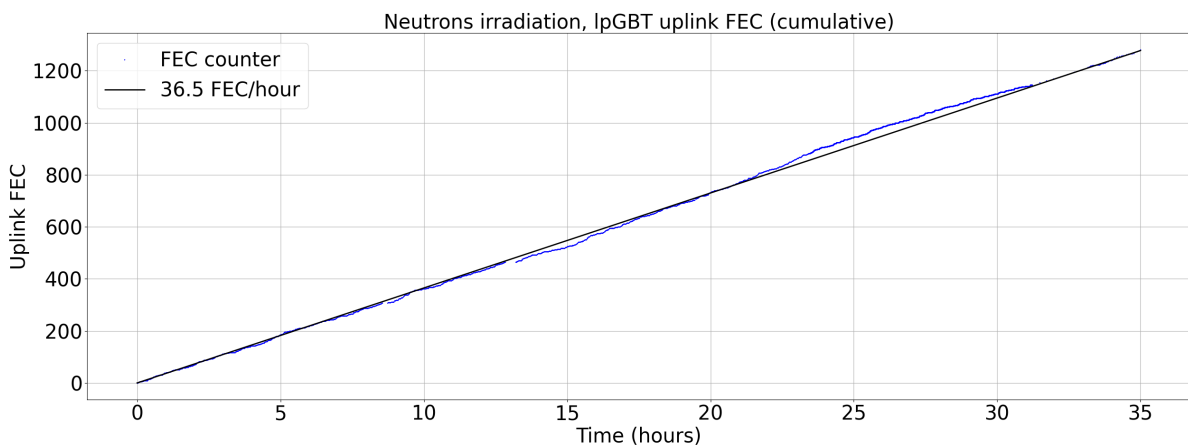
Figure 14: IpGBT Uplink FEC during irradiation

During irradiation, the uplink Forward Error Correction (FEC) was constantly increasing and protecting the uplink receiver against errors. In Figure 14 the uplink FEC during irradiation can be seen. A black line shows the FEC slope during the whole irradiation. This visual help shows that the FEC had its ups and downs but remained almost linear during the 35 hours. When looking at Section 6 further down, it can be seen that the neutrons flux was increasing and decreasing in the same way as the uplink FEC.

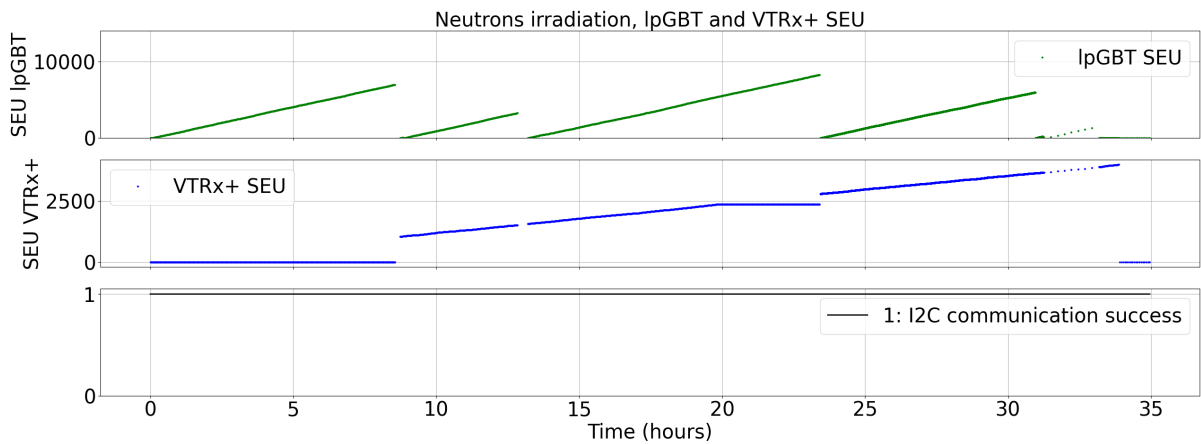
Figure 15: IpGBT Uplink FEC during irradiation

The SEU counter was monitored in both IpGBT and VTRx+ devices. The IpGBT SEU counter was read from its internal registers and the VTRx+ SEU counter from its own by using the I2CMaster of the IpGBT. In Figure 15 the VTRx+ and IpGBT SEU counters can be seen. The VTRx+ SEU counter was not read during the first 8.5 hours of irradiation. Then, it was read during the rest of the irradiation. The IpGBT SEU counter was read from the beginning. As it can be seen, the various resets performed in the IpGBT was making its SEU counter to reset but not the one from the VTRx+. For the IpGBT, the SEU counter slope was more or less constant with a value of around 800 SEU/hour. For the VTRx+, this value is around 100 SEU/hour. It can also be seen that the VTRx+ SEU counter stopped counting for around 3 hours. These constant SEU values were actually read from the I2CMaster of the IpGBT. There is no explanation for this behavior. Nevertheless

an IpGBT reset was enough to make the VTRx+ SEU counter work again. In case the I2CMaster of the IpGBT was the issue, an independent I2CMaster reset would probably also fix this issue.

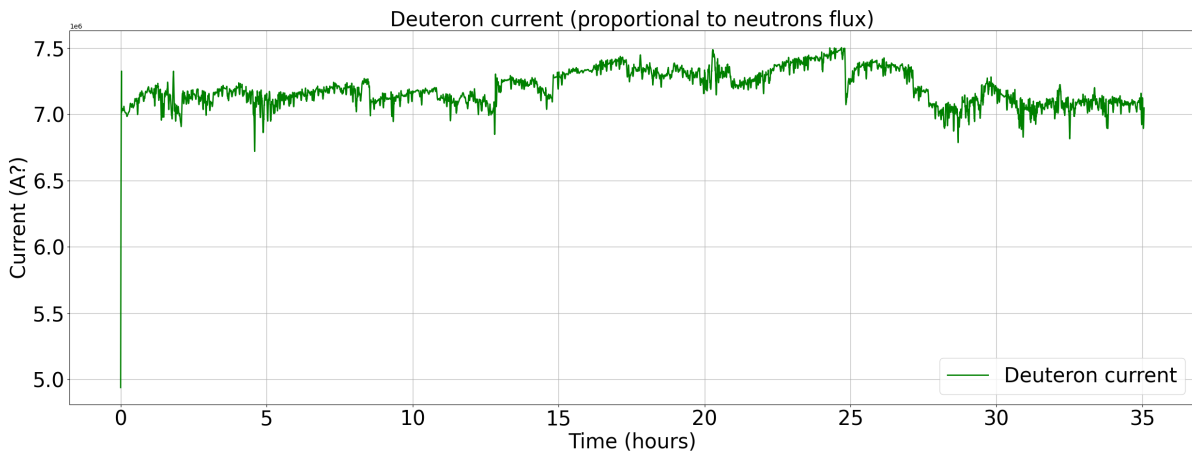
Figure 16: IpGBT Uplink FEC during irradiation

The deuteron current is a technique used to estimate the neutron flux in an irradiated system. The deuteron current is measured by the number of deuterons flowing into a specific particle detector per unit time and it is proportional to the neutron flux because the number of deuterons generated is directly related to the number of neutrons interacting with deuterium nuclei. In Figure 16 the deuteron current during the 35 hours of irradiation can be seen. This plot was previously filtered to remove the excessive noise that was screening out useful values. The neutrons flux was more or less constant during all the irradiation. There were small up and downs of the flux that can be linked to an increase and decrease of SEU and FEC. For instance, between hour 21 and 25, the uplink FEC counter slope slightly increased and this can be associated to a higher neutrons flux that can be seen in the deuteron current increase between the same hours.

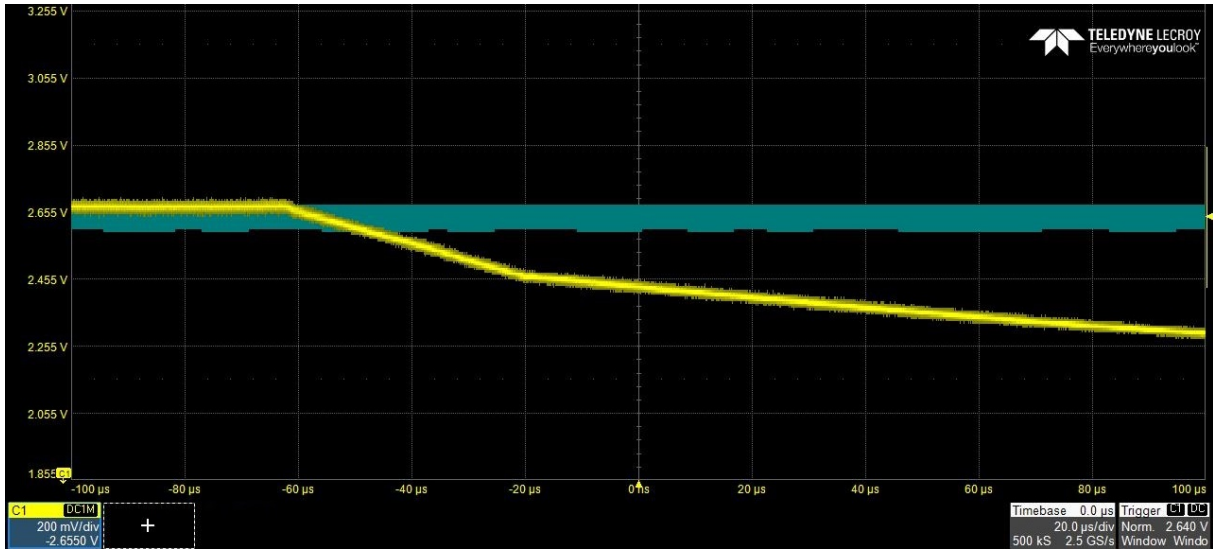
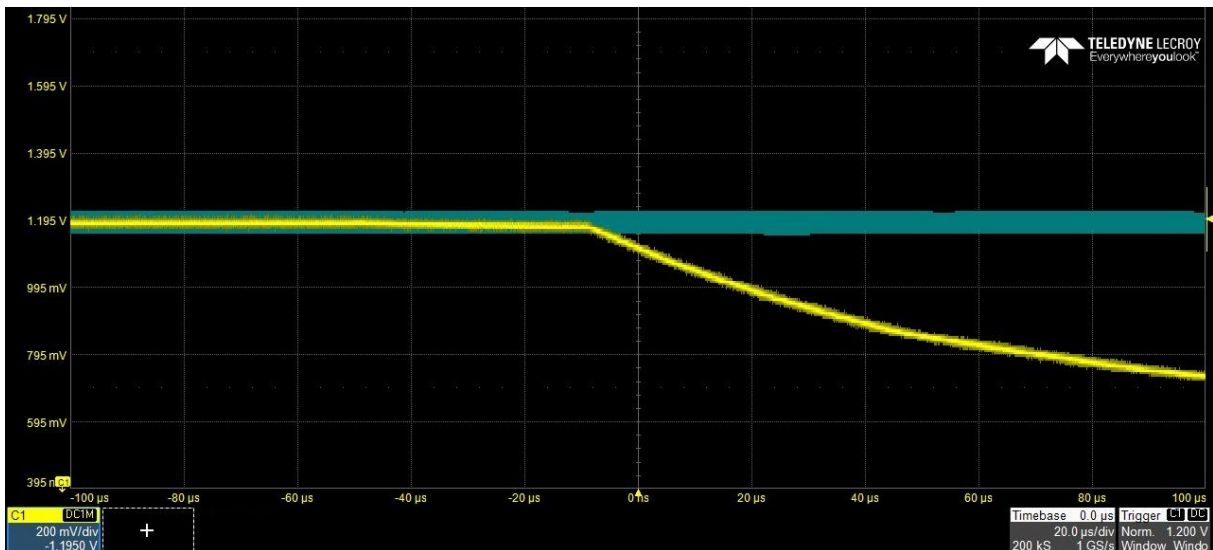
During irradiation both bPOL12V and bPOL2V5 outputs were monitored and the scopes were triggering when these values were exceeding the $\pm 8\%$ margin. During irradiation, both bPOLs did not have any suspicious voltage output that could be originated by the neutrons irradiation. In Figure 17 and Figure 18 an automatic screenshot of their outputs when performing power cycles tests on the system can be seen. The power cycles ensured, among other things, that the oscilloscopes were still properly configured at the end of the irradiation. Due to the small voltage and time scales set to capture possible spikes, just a small fraction of the voltage drop can be seen.

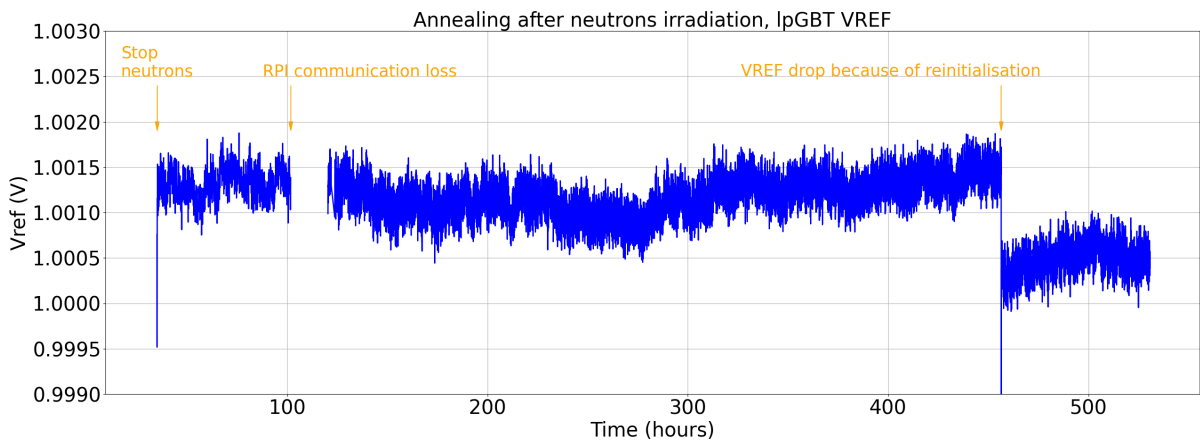
Figure 19: VREF during annealing

In Figure 19 the VREF during the annealing can be seen. The Voltage Reference remained stable around 1.0013 V. The only remarkable shift was caused by the re-initialisation of the IpGBT which made the VREF to be re-calibrated to a value closer to 1 V.

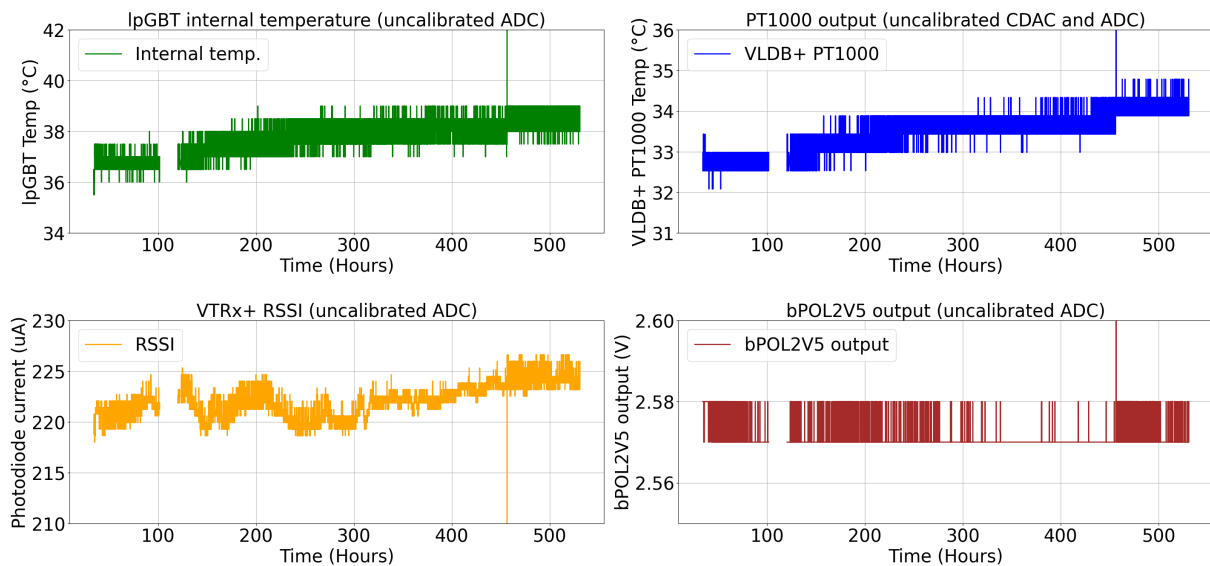
Figure 20: Performed IpGBT ADC readings during annealing

In Figure 20, the reading of the four ADCs during annealing is shown. Small drifts over time can be seen for the temperature readings and VTRx+ RSSI. A sudden change of the ADC readings at the hour 456 can be seen due to the IpGBT re-initialisation by which the VREF configuration was lost.

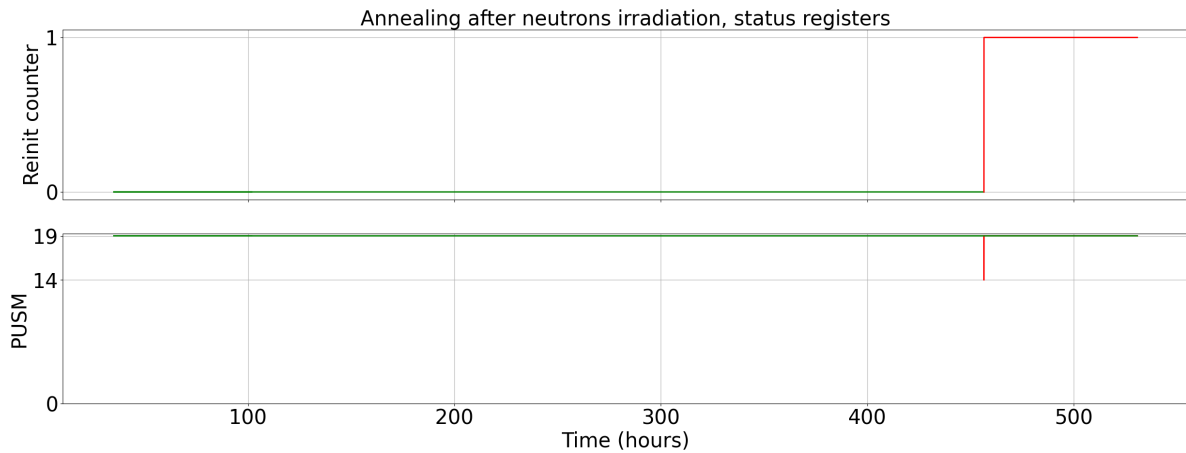
Figure 21: IpGBT and system status registers

During the annealing, there was a moment where the IpGBT power-up state machine jumped to PAUSE_FOR_DLL_CONFIG_DONE because of a Timeout and Watchdog trigger. Because of this, the system had to be reinitialised automatically by configuring the IpGBT and initialising the rest of the setup. The cause of the IpGBT reset is unknown. However, the IpGBT was able to properly operate just after this issue. The Figure 21 shows this event during the annealing.

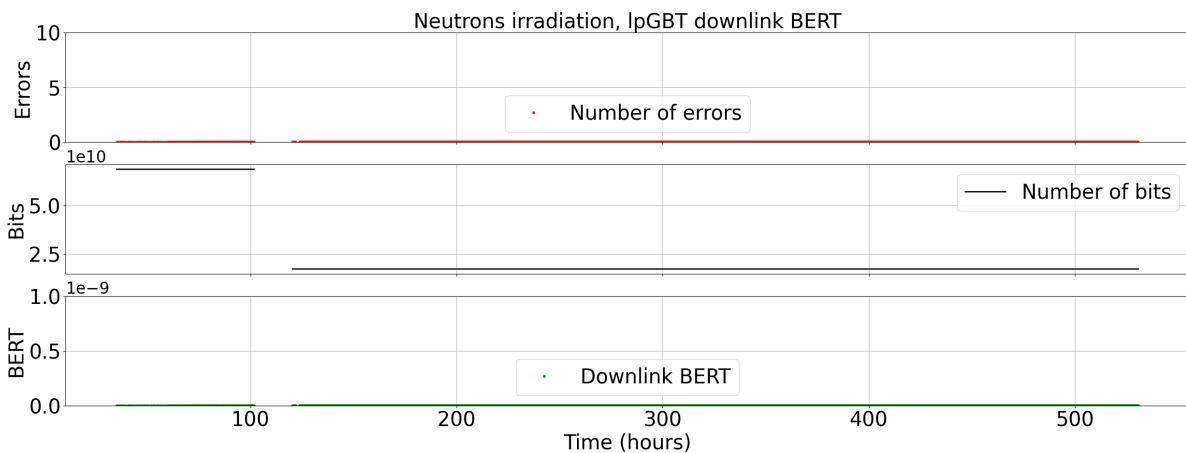
Figure 22: IpGBT Downlink BERT during annealing

During the annealing, no downlink errors were detected for every BERT cycle.

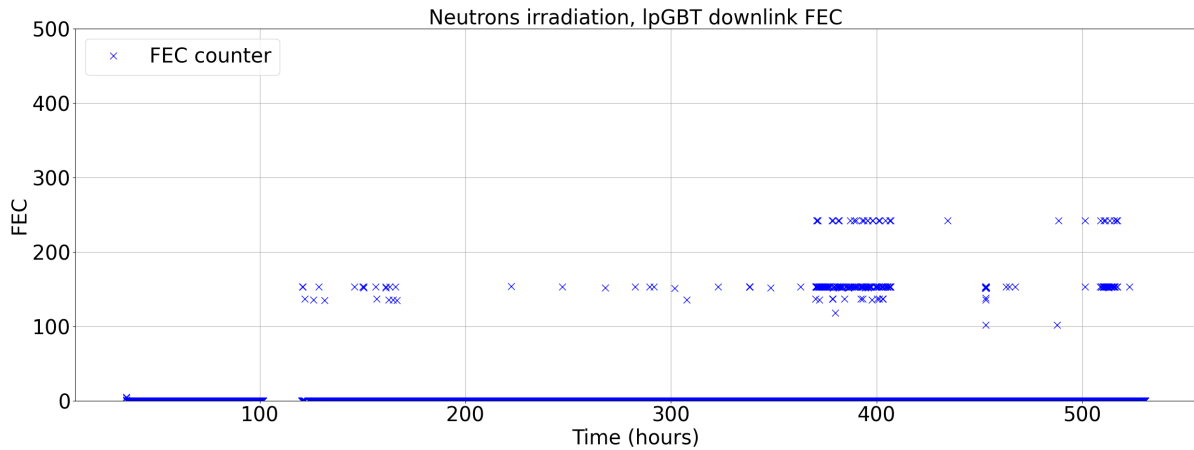
Figure 23: IpGBT Downlink FEC during annealing

During the annealing, the downlink FEC was most of the time zero. However, a few FEC were detected in some of the BERT cycles. It has been proven that these FEC were induced by an error in the software

explained in Section 7.
